**PRELIMINARY ACOUSTIC TESTS IN THE NEW HEADQUARTERS, WALES
(BAYNTON HOUSE, CARDIFF)**

Technological Report No. B-089/5
UDC 534.861.1 1966/49

D.K. Jones, B.Sc., A.Inst.P., A.M.I.E.R.E., Grad.I.E.E.

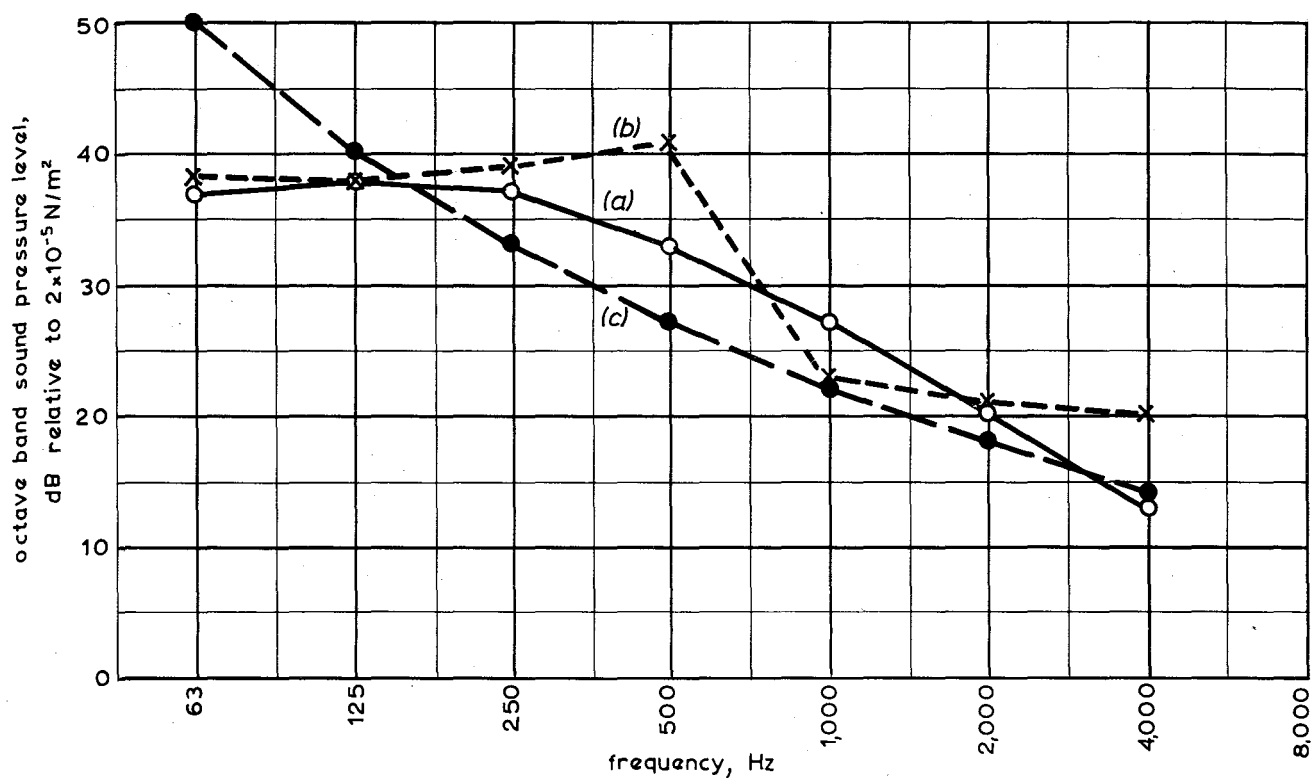
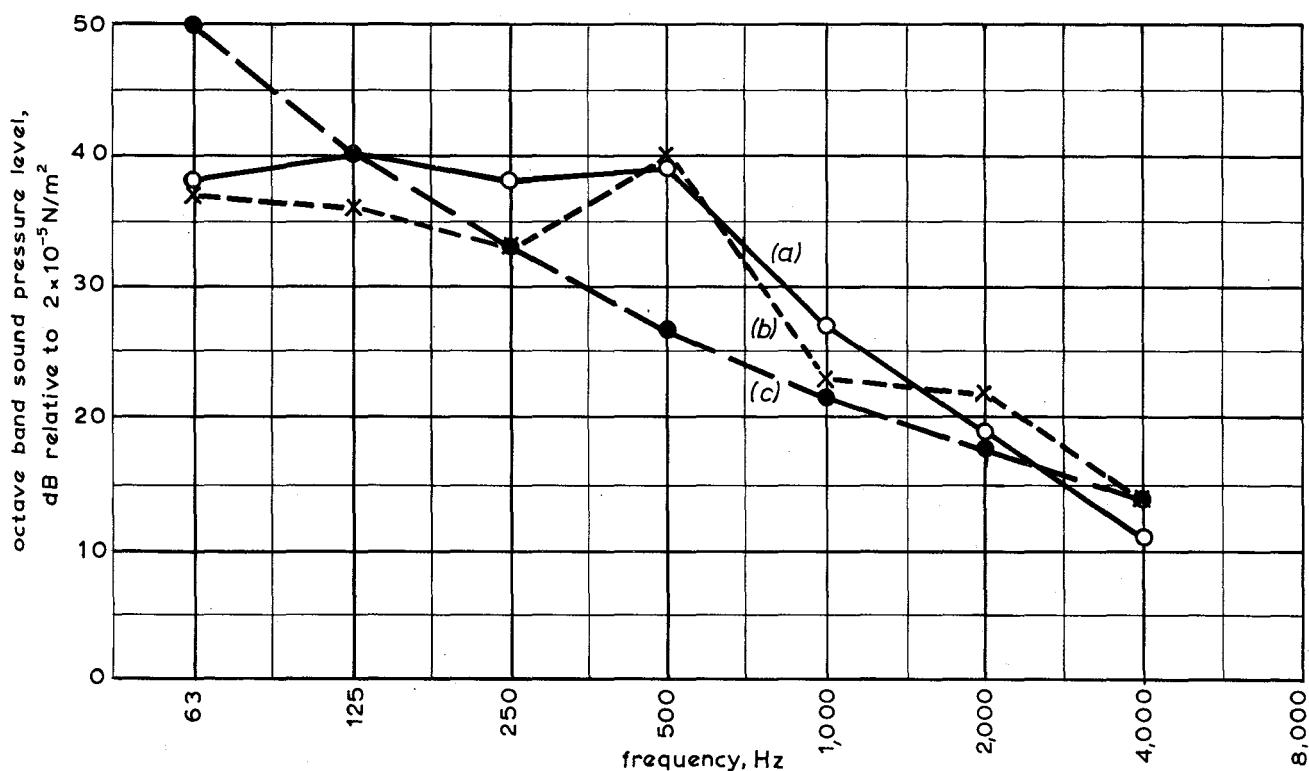
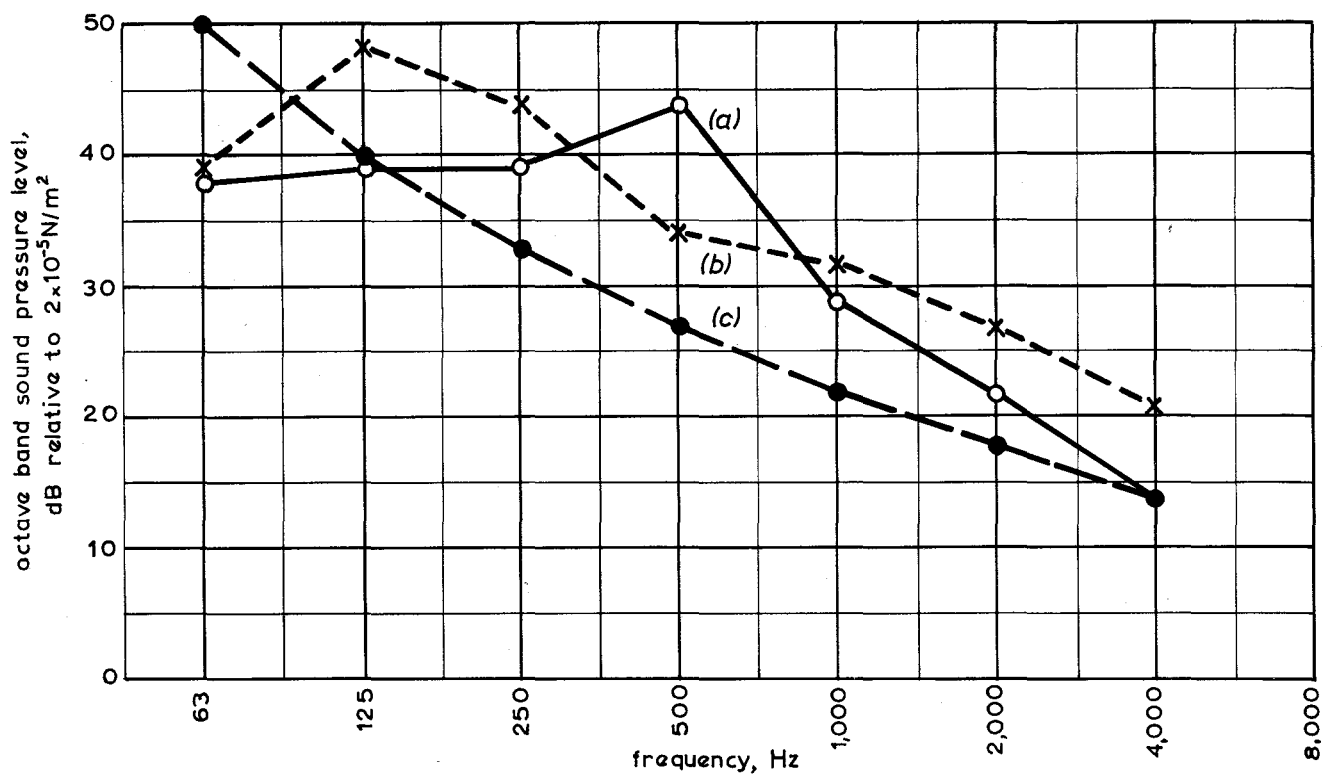
The noise levels measured in the three studios and their control cubicles are given in Figs. 20, 21 and 22. The prominent peaks in the noise curves are due to mechanical vibrations of the vanes of the extract grilles which are excited by the turbulent airflow past the peak of the "Y"-shaped vanes. Even in rooms in which the grilles do not ring, for example cubicle 4, the noise levels still exceed the criterion curves. The ventilation system is not yet balanced but there appears to be a widespread noise

component centred at about 500 Hz in all of these areas.

In general, the background noise in all areas except the narrator's studio is excessive. Many of the extract grilles emit pure tones from their "Y"-shaped vanes which are forced into oscillation by the turbulent airflow past their tips. In all studios, even those which have no grilles fitted, the noise spectrum shows a broad hump in the 500 Hz region. The contractors state that the ventilation plant is not yet balanced and that they are taking measures to damp out the oscillations of the vanes of the grilles.

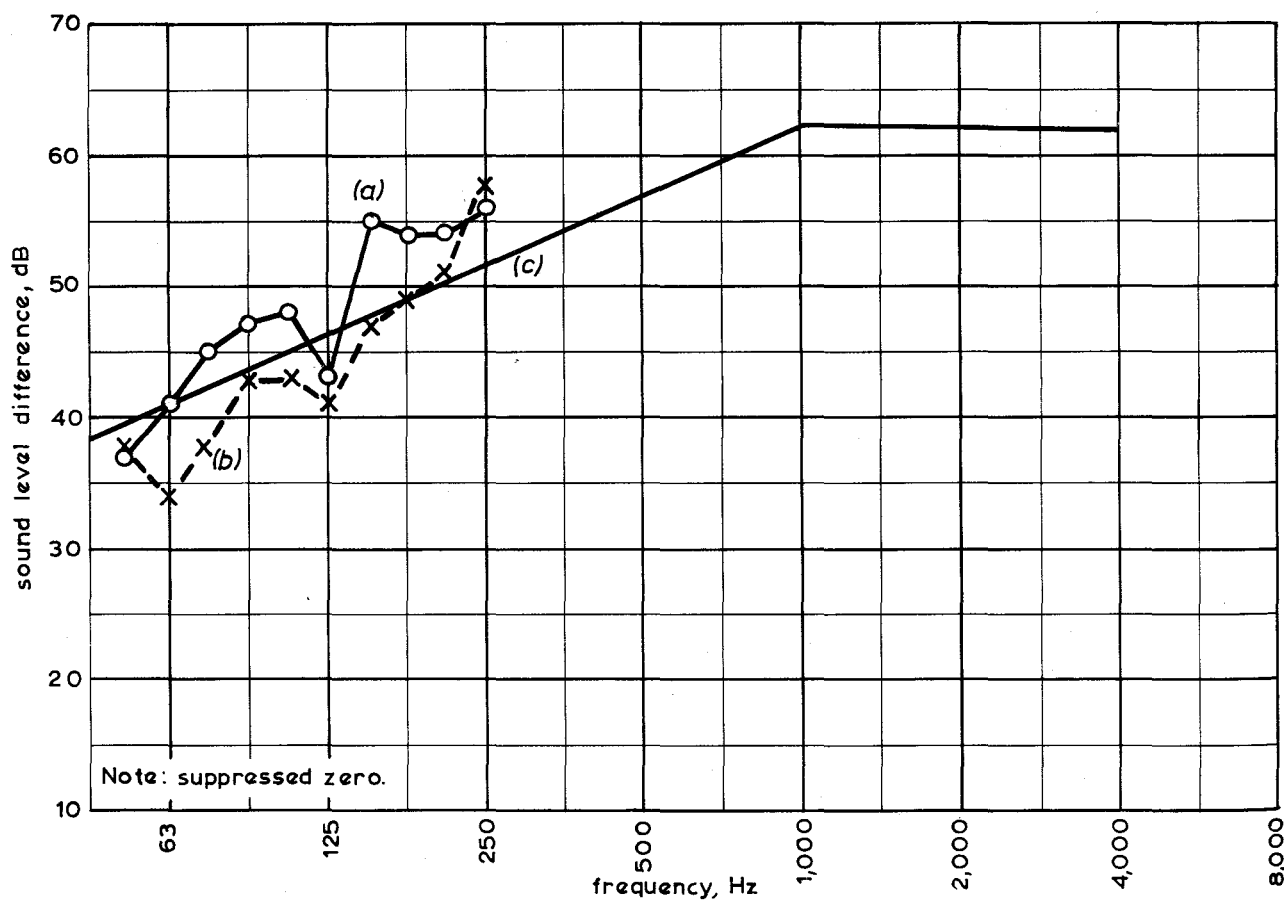
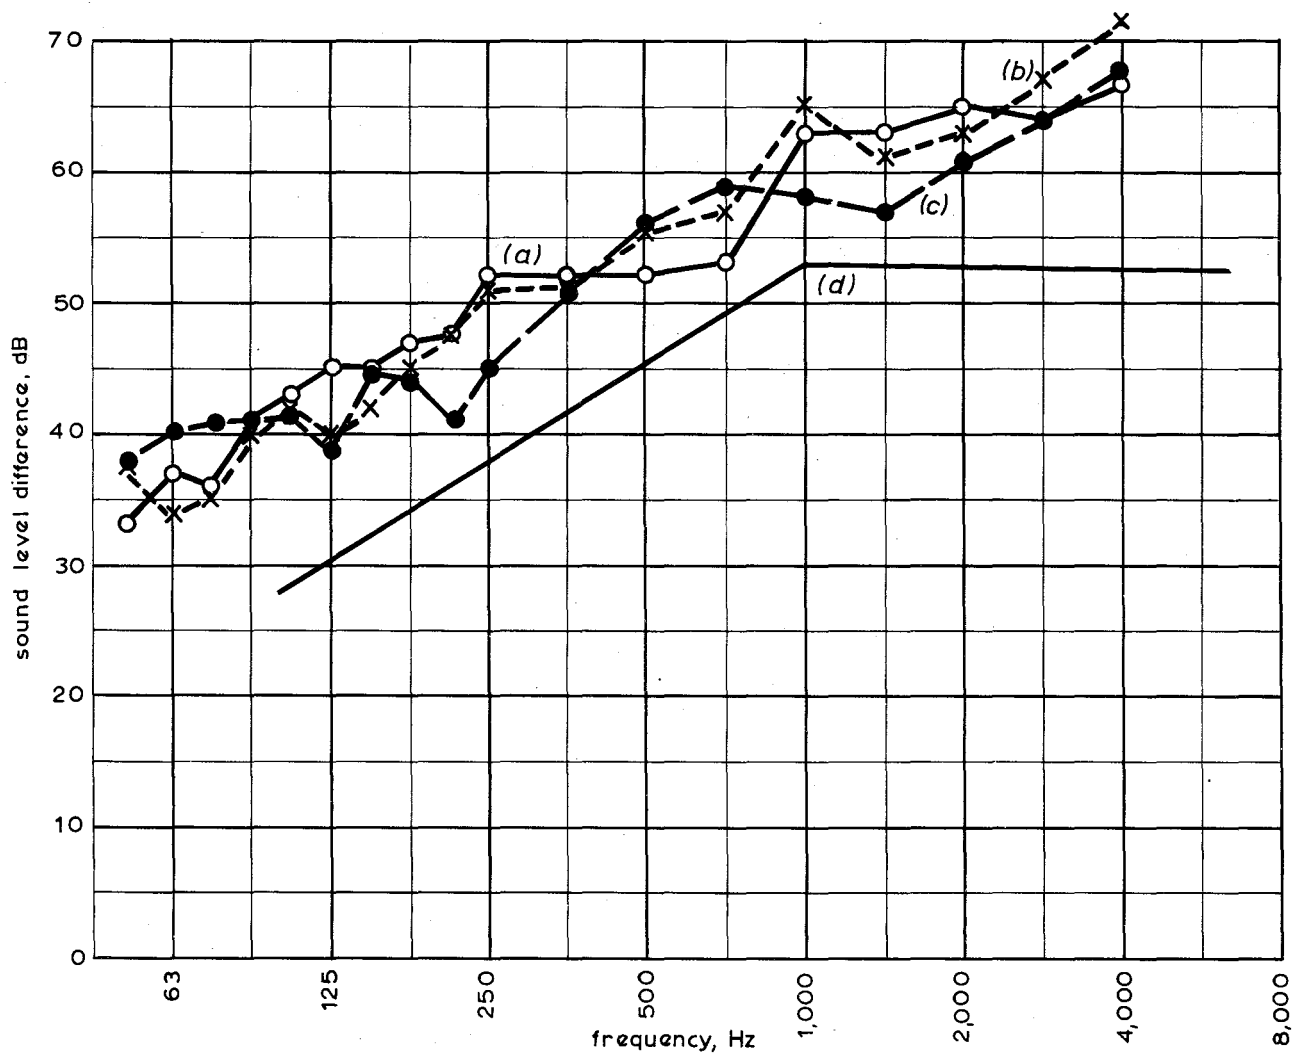
Sound insulations were measured between adjacent pairs of rooms and the measured results are shown in Figs. 23 and 24. The high level of ventilation noise masks the sound in the receiving rooms and it was thus not possible to measure the insulation at frequencies above 250 Hz from Studio 6 to Cubicle 5 or from Studio 5 to Cubicle 4. The insulation between Studios 4, 5 and 6 and other cubicles is adequate.
